Manhole Inspection Summary

Manhole # S57K__020MH

Insp Date: **5/15/08 8:35 AM**

Location Address: **3927 fait st**

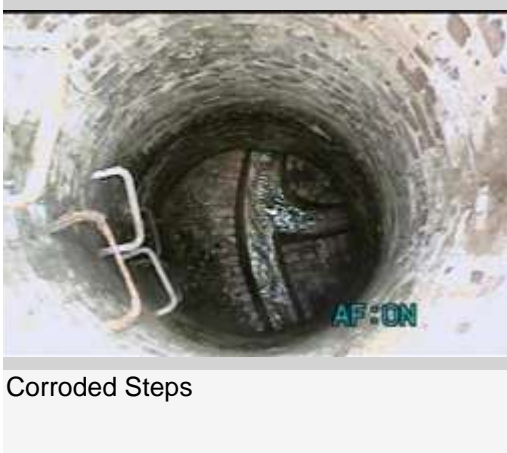
Defect 2

Count: **7** Missing: **0** ☒ **Corroded**

Corroded Steps

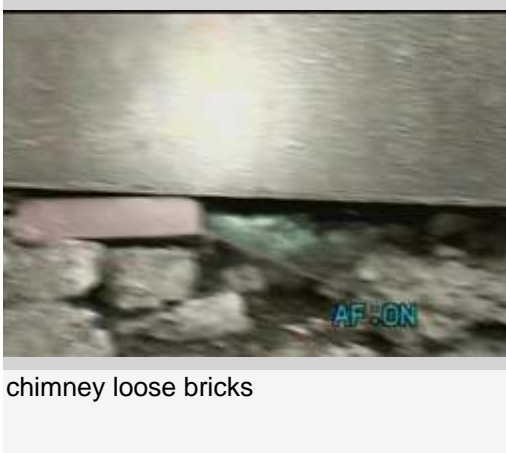
Defect 1

Condition: ☐ Sound ☐ Cracked ☐ Root Intrusion ☒ **Loose Brick** ☐ Deteriorated

chimney loose bricks

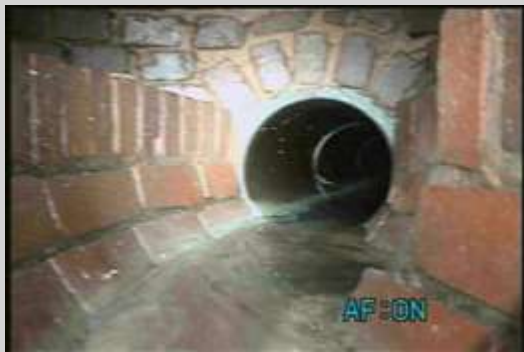
12 O'Clock Outflow

8 in. Circular Gravity Sewer
Pipe Out @ 12 O'Clock

Pipe Material: **Clay** ☐ Pipe Lined

Invert Depth: **13.20** (ft.) Flow Characteristics: **Fast**

Infiltration: **None** Pipe Seal Cond: **Unknown**

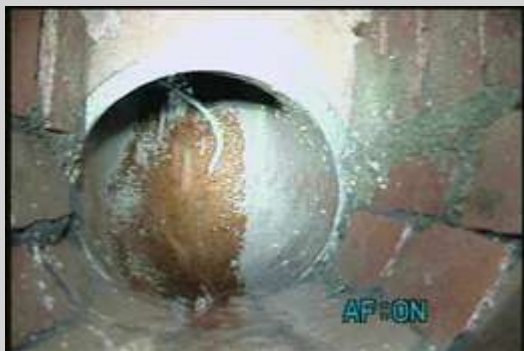
3 O'Clock Inflow

8 in. Circular Gravity Sewer
Pipe In @ 3 O'Clock

Pipe Material: **Clay** ☐ Pipe Lined

Invert Depth: **12.90** (ft.) Flow Characteristics: **Fast**

Infiltration: **None** Pipe Seal Cond: **Unknown**

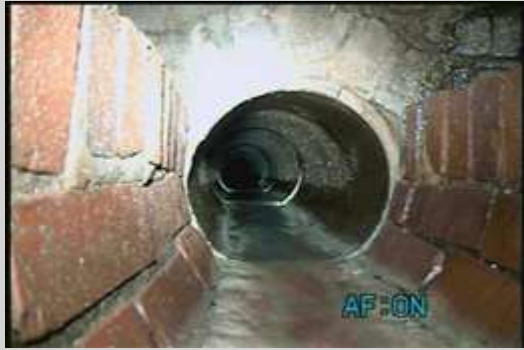
6 O'Clock Inflow

8 in. Circular Gravity Sewer

Pipe In @ 6 O'Clock

Pipe Material: **Clay** ☐ Pipe Lined

Invert Depth: **12.90** (ft.) Flow Characteristics: **Fast**

Infiltration: **None** Pipe Seal Cond: **Unknown**
